JOINT BASE PEARL HARBOR – HICKAM / RED HILL, HAWAII

FINAL 2011 BIENNIAL INTEGRITY TESTING REPORT OF BULK FIELD CONSTRUCTED UNDERGROUND STORAGE TANK 14

JOINT BASE PEARL HARBOR - HICKAM / RED HILL, HAWAII

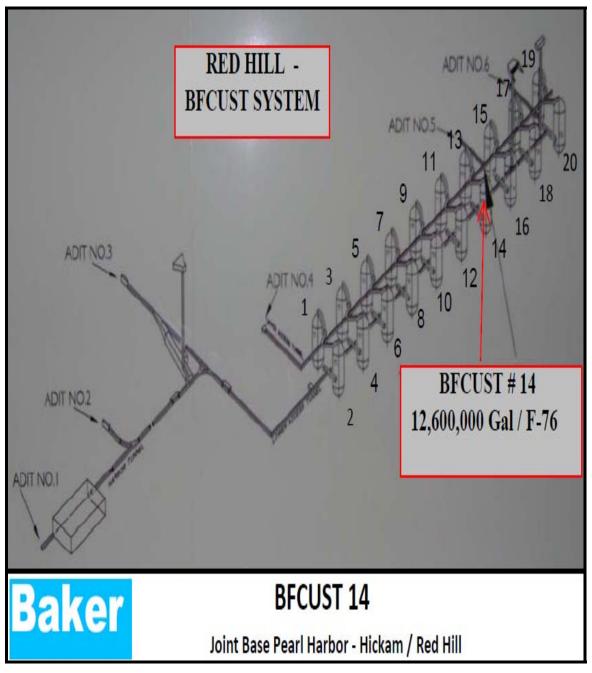
Figure 1-1: RED HILL – System Layout

A Mass Technology Corporation (MTC) integrity test on BFCUST 14 was performed from 25 February to 4 March 2011. Table 1-1 provides a description of the system tested. Figure 1-1 provides a detail of the Red Hill system layout and location of BFCUST 14. Figures 1-2 and 1-3 provide photographs of typical top and bottom of tank access.

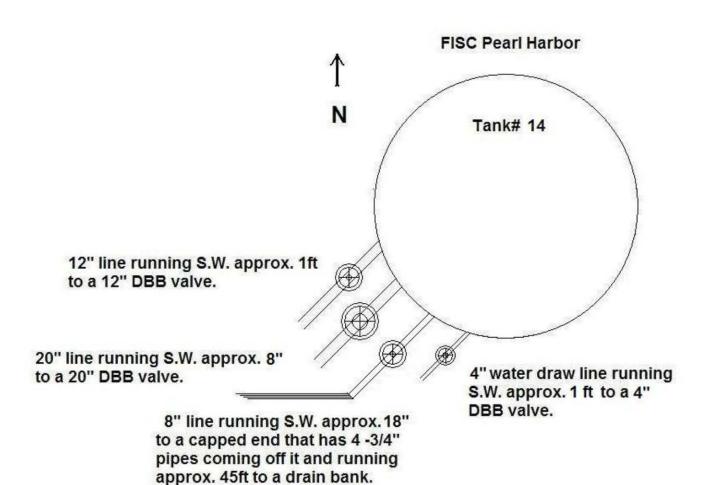
Tank Data Tank # 14

Diameter: 100 ft. Height: 250 ft.

Tank Type: Vertical UST Contents: F-76

Properties: 0.82 Specific Gravity Product Level: 210.7 ft.

Start Date: 02-25-2011 Completion Date: 03-04-2011 Unit Operator: Alfred Thyrring Test Results: Certified Tight

All dimensions, line locations, sizes and valve descriptions have been furnished by the facility operator.

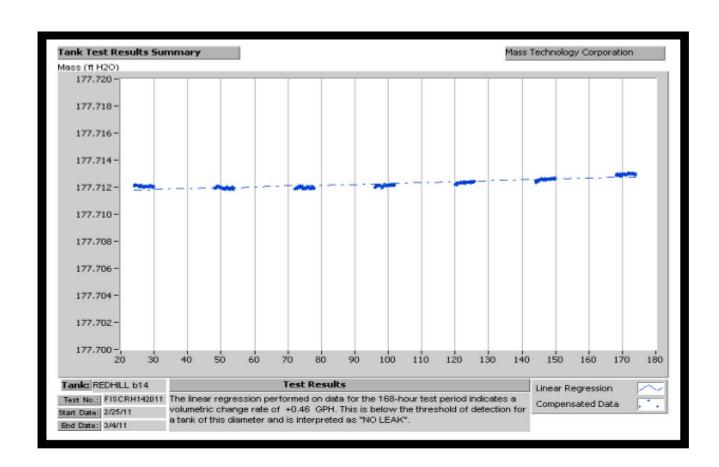
The fluid mass data was recorded over a 168-hour period. A linear regression of the recorded fluid mass data resulted in a leak rate detected below the minimum detection level of 0.7 gallons per hour. All tank valves were adequately secured such that any fluid loss was isolated to leakage. Therefore, the containment integrity of the tank was not compromised and the test is considered conclusive.

Tank # 14 is certified to be tight.
