FINAL 2011 BIENNIAL INTEGRITY TESTING REPORT OF BULK FIELD CONSTRUCTED UNDERGROUND STORAGE TANK 20

JOINT BASE PEARL HARBOR – HICKAM / RED HILL, HAWAII

Submitted by: Michael Baker Jr., Inc. Virginia Beach, VA

Date: 8 APRIL 2011

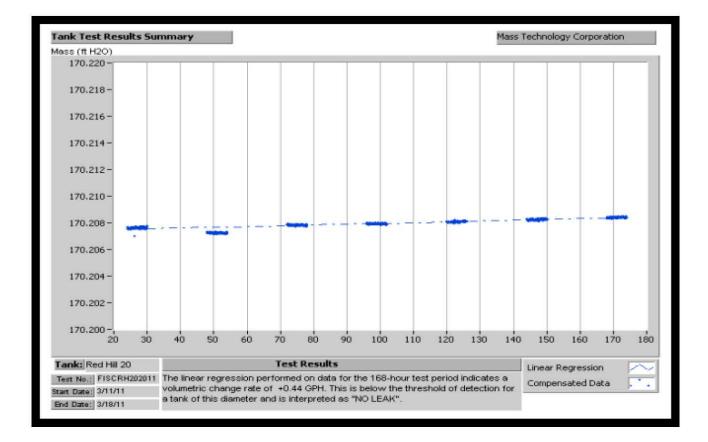
The fluid mass data was recorded over a 168-hour period. A linear regression of the recorded fluid mass data resulted in a leak rate detected below the minimum detection level of 0.7 gallons per hour. All tank valves were adequately secured such that any fluid loss was isolated to leakage. Therefore, the containment integrity of the tank was not compromised and the test is considered conclusive.

Tank # 20 is certified to be tight.
