JOINT BASE PEARL HARBOR - HICKAM / RED HILL, HAWAII

Defense Logistics Agency Energy Ft. Belvoir, Virginia

Michael Baker Jr., Inc. Virginia Beach, VA

FINAL 2011 BIENNIAL INTEGRITY TESTING REPORT OF BULK FIELD CONSTRUCTED UNDERGROUND STORAGE TANK 8

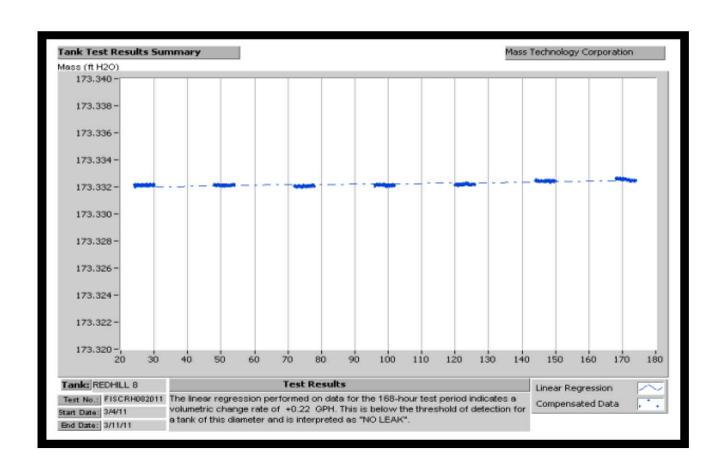
The fluid mass data was recorded over a 168-hour period. A linear regression of the recorded fluid mass data resulted in a leak rate detected below the minimum detection level of 0.7 gallons per hour. All tank valves were adequately secured such that any fluid loss was isolated to leakage. Therefore, the containment integrity of the tank was not compromised and the test is considered conclusive.

Tank # 08 is certified to be tight.
