JOINT BASE PEARL HARBOR – HICKAM / RED HILL, HAWAII

30 MARCH 2011

# FINAL 2011 BIENNIAL INTEGRITY TESTING REPORT OF BULK FIELD CONSTRUCTED UNDERGROUND STORAGE TANK 9

# ${\bf JOINT~BASE~PEARL~HARBOR~HICKAM/RED~HILL, HAWAII}$

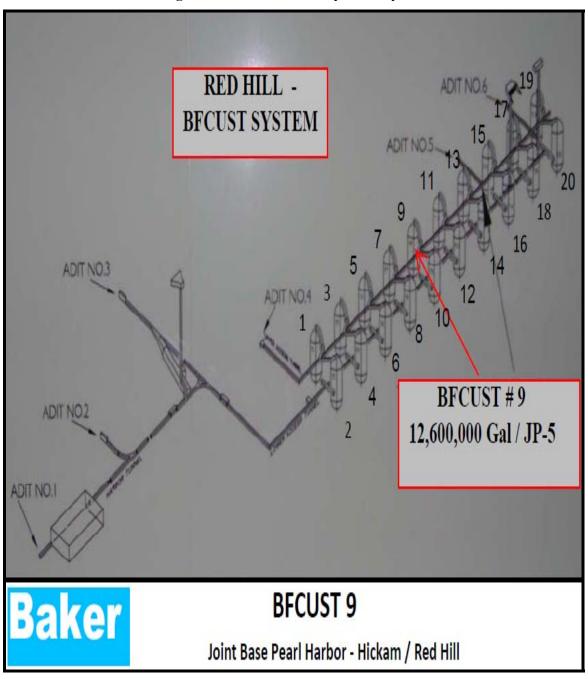
Figure 1-1: RED HILL – System Layout

A Mass Technology Corporation (MTC) integrity test on BFCUST 9 was performed from 28 February to 9 March 2011. Table 1-1 provides a description of the system tested. Figure 1-1 provides a detail of the Red Hill system layout and location of BFCUST 9. Figures 1-2 and 1-3 provide photographs of typical top and bottom of tank access.

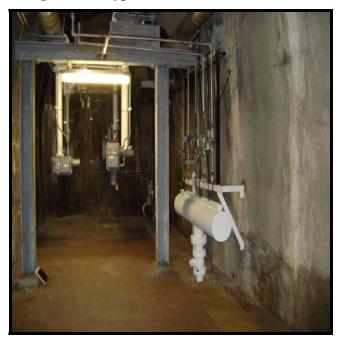
**Figure 1-2: Typical Tank Bottom Access**

BFCUST 9 is 100 feet in diameter, 250 feet in height and has a capacity of 12,600,000 gallons of JP-5. The BFCUSTs at Red Hill are constructed within Red Hill and are accessible through an underground tunnel system. The top tunnel is located approximately 60 feet below the top section of the tank. The bottom tunnel is located at the same elevation as the tank's base. runs equal to the bottom level of the tanks. The issue / receipt and water drain pipelines are adjacent to the tank and immediately accessible from within the lower tunnel..

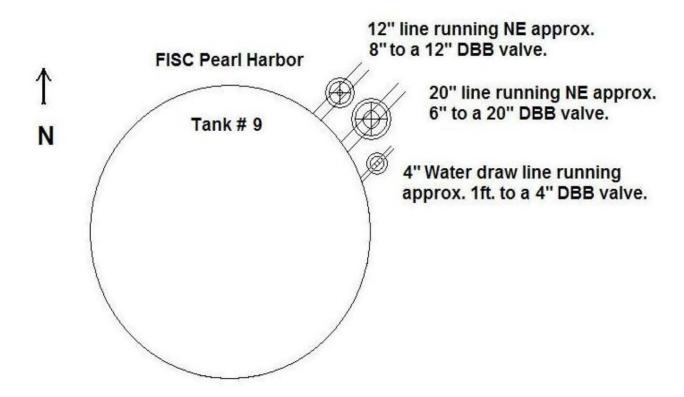
Diameter:100 ft.Height:250 ft.Tank Type:Vertical USTContents:JP-5Properties:0.80 Specific GravityProduct Level:211.8 ft.

All dimensions, line locations, sizes and valve descriptions have been furnished by the facility operator.

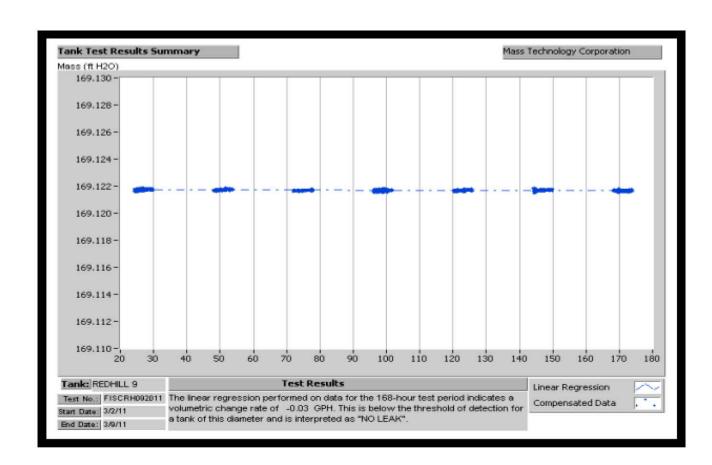
The fluid mass data was recorded over a 168-hour period. A linear regression of the recorded fluid mass data resulted in a leak rate detected below the minimum detection level of 0.7 gallons per hour. All tank valves were adequately secured such that any fluid loss was isolated to leakage. Therefore, the containment integrity of the tank was not compromised and the test is considered conclusive.

Tank # 09 is certified to be tight.
