FINAL 2013 BIENNIAL LEAK DETECTION TESTING REPORT OF BULK FIELD-CONSTRUCTED UNDERGROUND STORAGE TANK 9, RED HILL UNDERGROUND FUEL STORAGE FACILITY

JOINT BASE PEARL HARBOR- HICKAM, HAWAII

Date:
17 APRIL 2013

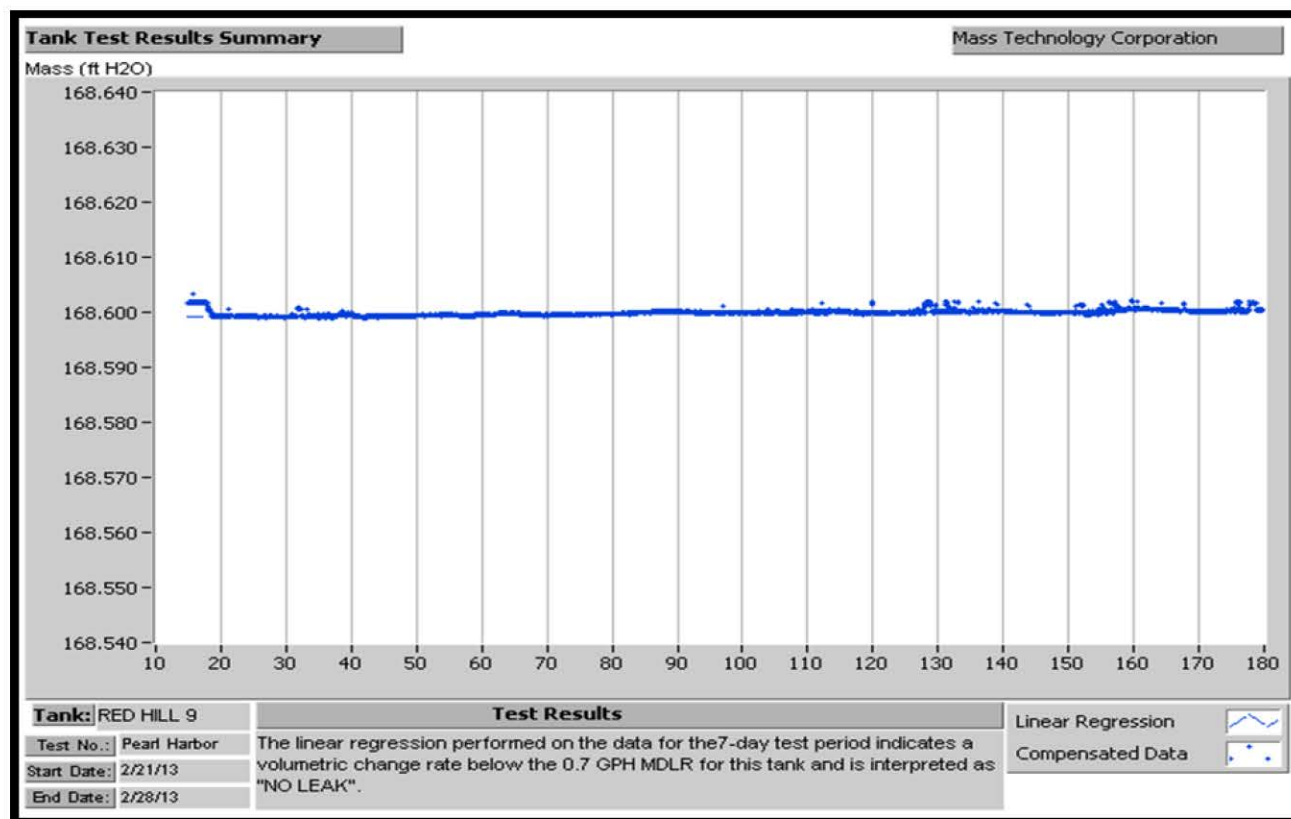
The fluid mass data was recorded over a 168-hour period. A linear regression of the recorded fluid mass data resulted in a leak rate detected below the minimum detection level of 0.7 gallons per hour. All tank valves were adequately secured such that any fluid loss was isolated to leakage. Therefore, the containment integrity of the tank was not compromised and the test is considered conclusive.
