# FINAL 2013 BIENNIAL LEAK DETECTION TESTING REPORT OF BULK FIELD-CONSTRUCTED UNDERGROUND STORAGE TANK 20

**JOINT BASE PEARL HARBOR-  
HICKAM / RED HILL, HAWAII**

*Project: 127964  
Task: 4.1.033*

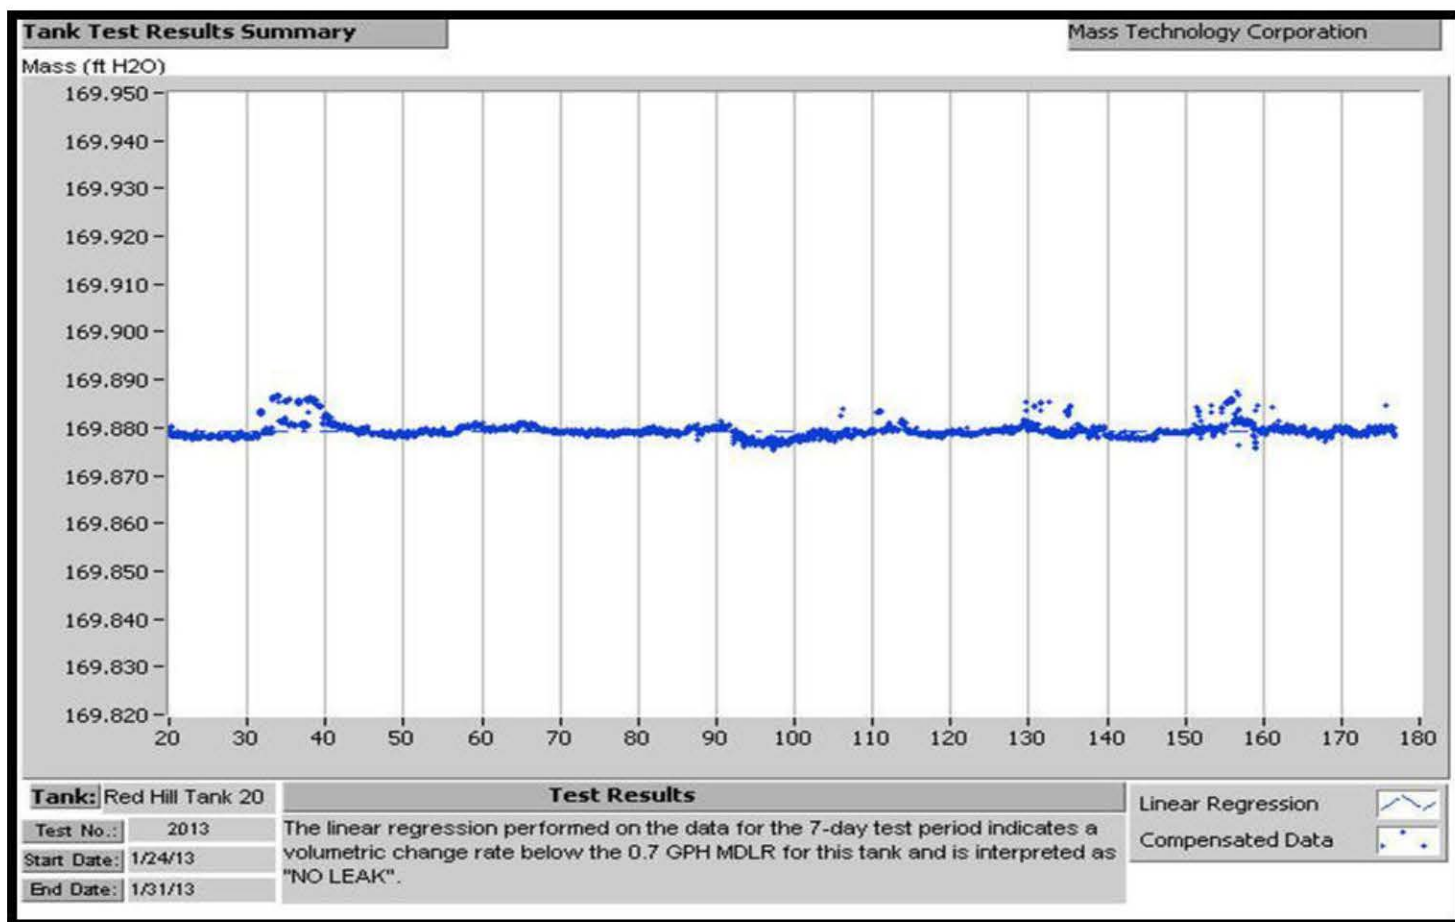
The fluid mass data was recorded over a 168-hour period. A linear regression of the recorded fluid mass data resulted in a leak rate detected below the minimum detection level of 0.7 gallons per hour. All tank valves were adequately secured such that any fluid loss was isolated to leakage. Therefore, the containment integrity of the tank was not compromised and the test is considered conclusive.

Tank # 20 is certified to be tight.
